Contract #: 04-0120F4Cty: SF/ALA Rte: 80 PM: 13.2/13.9File #: 69.28**WELDING INSPECTION REPORT****Resident Engineer:**Pursell, Gary**Address:** 333 Burma Road**City:** Oakland, CA 94607**Report No:** WIR-010407**Date Inspected:** 25-Nov-2009**Project Name:** SAS Superstructure**OSM Arrival Time:** 1900**Prime Contractor:** American Bridge/Fluor Enterprises, a JV**OSM Departure Time:** 700**Contractor:** Zhenhua Port Machinery Company, Ltd (ZPMC), Changxing Island **Location:** Shanghai, China**CWI Name:** Wang Chung Ging**CWI Present:** Yes No**Inspected CWI report:** Yes No N/A**Rod Oven in Use:** Yes No N/A**Electrode to specification:** Yes No N/A**Weld Procedures Followed:** Yes No N/A**Qualified Welders:** Yes No N/A**Verified Joint Fit-up:** Yes No N/A**Approved Drawings:** Yes No N/A**Approved WPS:** Yes No N/A**Delayed / Cancelled:** Yes No N/A**Bridge No:** 34-0006**Component:** OBG/TOWER**Summary of Items Observed:**

HEAVY DOCK

OBG SEGMENT 3EAST

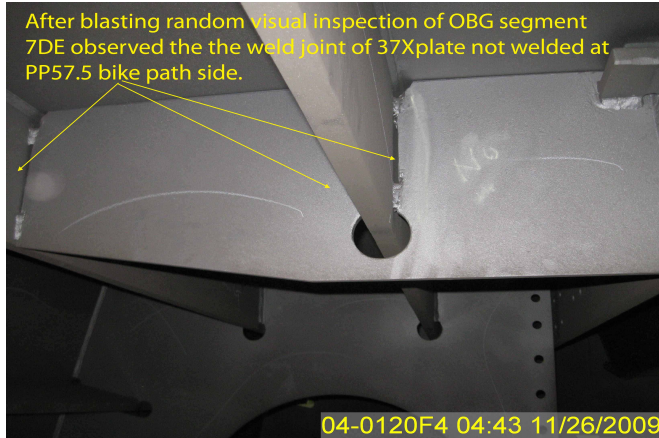
This Quality Assurance (QA) Inspector performed random visual inspection after blasting along with Caltrans Quality Assurance (QA) Inspector Mr. Paul Dawson on inside upper panel, floor beam and inside corner assembly diaphragm of OBG segment 7DE. During the inspection we found normal minor gouges, arc strikes, spatter,

undercut. The major item was ZPMC did not weld the weld joint of 37X plate with deck panel I rib at PP57.5 (bike path side). See attached photos for additional information.
